# Inferior vena cava filter removal after prolonged dwell time of 2310 days

Ankit H. Shah, MD, Andrew Lichliter, MD, and Marco Cura, MD

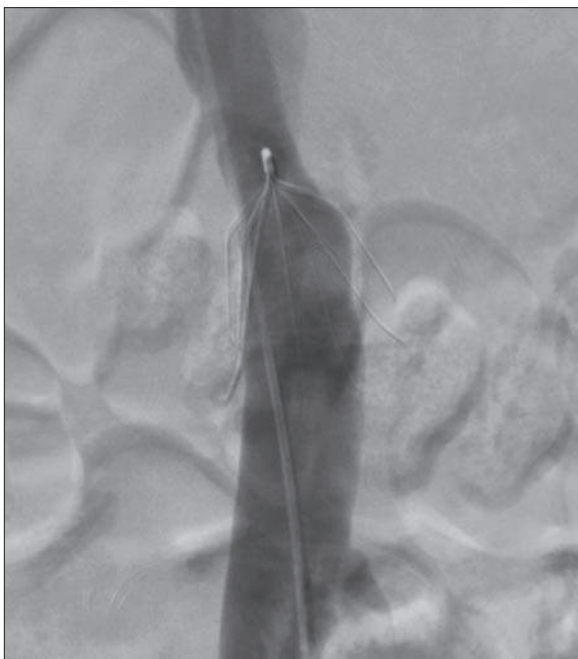
In the interventional suite, a vascular sheath was positioned in the right internal jugular vein after ultrasound-guided Seldinger technique access. An IVC venogram confirmed IVC perforation (*Figure 2*). Conventional snare techniques were unsuccessful at retrieval. An advanced snare technique was then employed. Two coaxial sheaths were positioned over an Amplatz wire (Cook Medical Inc., Bloomington, IN). Two wires were advanced, one anterior and the other posterior to the filter. The anterior wire was exchanged for a snare sys-

**Figure 2.** Venogram confirming inferior vena cava perforation.
